LEXUS VOLUNTARY SAFETY RECALL

**Certain 2004 and 2005 Model Year ES 330 and RX 330 and Certain 2006 Model Year RX400h vehicles:
Crankshaft Pulley**

Q&A

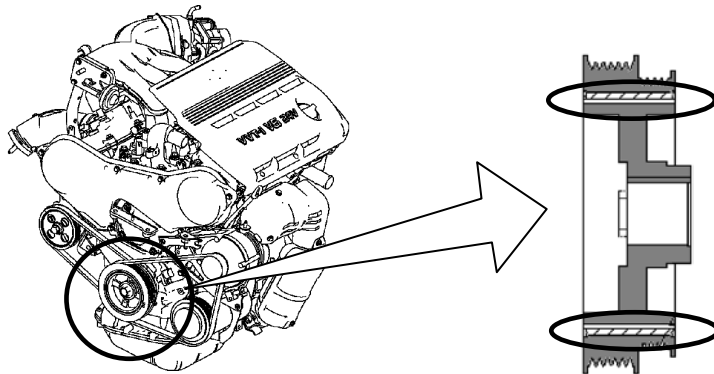
A1: In certain 2004 and 2005 Model Year ES 330 and RX 330 and certain 2006 Model Year RX400h vehicles equipped with a 1MZ-FE or 3MZ-FE V6 engine, the amount of adhesive agent applied between the outer ring and the rubber torsional damper (inner ring) in the crankshaft pulley may be inadequate. If the adhesive is insufficient, there is a possibility that the outer ring may become misaligned and it may not properly rotate with the inner ring, causing noise and/or illumination of the discharge warning light. In some cases, the belt for the power steering pump may become detached from the pulley. The driver may notice a sudden increase in steering effort. A sudden increase in steering effort could increase the risk of a crash.

A2: The cause of this condition is an insufficient amount of adhesive agent applied between the outer ring and the rubber torsional damper (inner ring) in the crankshaft pulley.

A5: Owner notification letters sent by first class mail will begin mailing by January 2012. Any Lexus dealer will inspect the crankshaft pulley, and if there is need to repair it, the dealer will replace the crankshaft pulley at **NO CHARGE**. In addition, in cases where the crankshaft pulley separated, the dealer will replace other parts which need repair at **NO CHARGE**.
