November 9, 2011

**TOYOTA VOLUNTARY SAFETY RECALL**  
**2004/2005/2006 Models of Avalon, Camry, Highlander, Sienna, Solara vehicles: Crankshaft Pulley**

Q&A

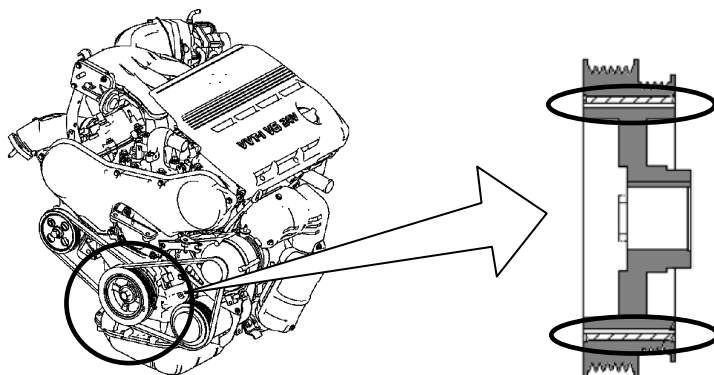
A1: In certain 2004 and 2005 MY Camry, Highlander, Sienna, Solara, certain 2004 MY Avalon and certain 2005 and 2006 MY Highlander HV vehicles equipped with a 1MZ-FE or 3MZ-FE engine, the amount of adhesive agent applied between the outer ring and the rubber torsional damper (inner ring) in the crankshaft pulley may be inadequate. If the adhesive is insufficient, there is a possibility that the outer ring may become misaligned and it may not properly rotate with the inner ring, causing noise and/or illumination of the discharge warning light. In some cases, the belt for the power steering pump may become detached from the pulley. The driver may notice a sudden increase in steering effort. A sudden increase in steering effort could increase the risk of a crash.

A2: The cause of this condition is an insufficient amount of adhesive agent applied between the outer ring and the rubber torsional damper (inner ring) in the crankshaft pulley.

A5: Owner notification letters sent by first class mail will begin mailing later this year. Any Toyota/Lexus dealer will inspect the crankshaft pulley, and if there is need to repair it, the dealer will replace the crankshaft pulley at **NO CHARGE**. In addition, in cases where the crankshaft pulley separated, the dealer will replace other parts which need repair at **NO CHARGE**.
